Inventory No. QA-66

Maryland Historical Trust Maryland Inventory of Historic Properties Form

1. Nam	e of Property	(indicate preferred r	name)			
historic	"Tilghman's C	hance," "Tristam's Adventur	e," "Tristam	ı's Ridge Coı	rected" etc.	
other	Thomas Farm,	C. P. Merrick Farm (modern)

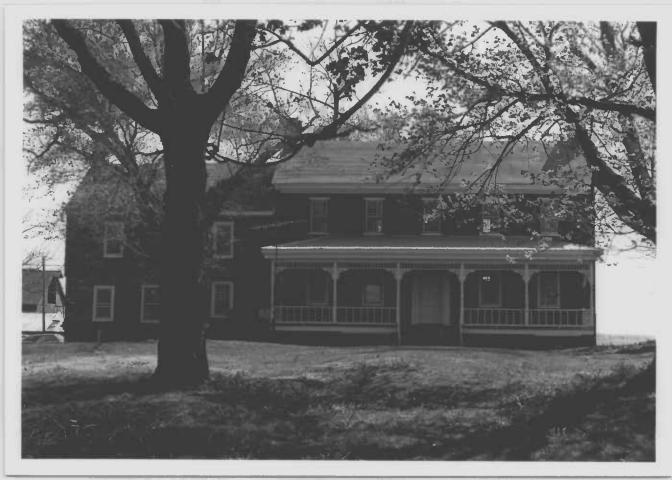
QA-66 C.P. Merrick Farm
Merrick Corner
Ingleside vicinity
Orlando Ridout V 1980
Front facade

The brickwork is laid in Flemish Bond above a three-course bond foundation, with no water table or belt course. At one time the façade was painted red, and may have had stenciled joints, as at Ripley (QA-55, also built in 1805). The majority of the window openings are finished with king closers, although two jambs feature queen closers on the edge of the opening rather than being set back one-half brick. The flat lintels consist of a single rowlock course; the sills are wood. The eaves are trimmed with a box cornice with a large complex crown mold and handsome complex bed mold with a Wall-of-Troy dentil course. The roof is now covered with asphault shingles.

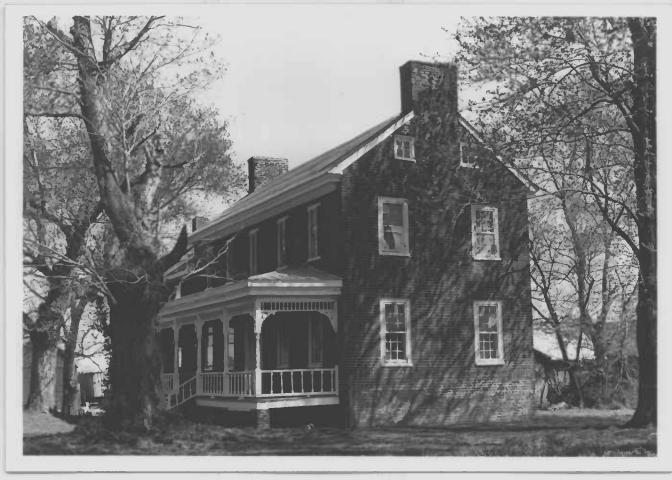
QA-66 C.P. Merrick Farm
Merrick Corner
Ingleside vicinity
Orlando Ridout V 1980
View from northwest

The west gable wall of the main house is also laid in Flemish Bond above a three-course bond foundation. There are two 9/9 windows flanking the chimney on the first floor, two 9/6 windows on the second floor, and a pair of four-light windows in the upper gables. The first and second floor windows are trimmed the same as on the front facade; the third story windows have beaded and pegged frames. The eaves are finished with beaded and tapered rakeboards with an applied band of ogee/astragal molding.

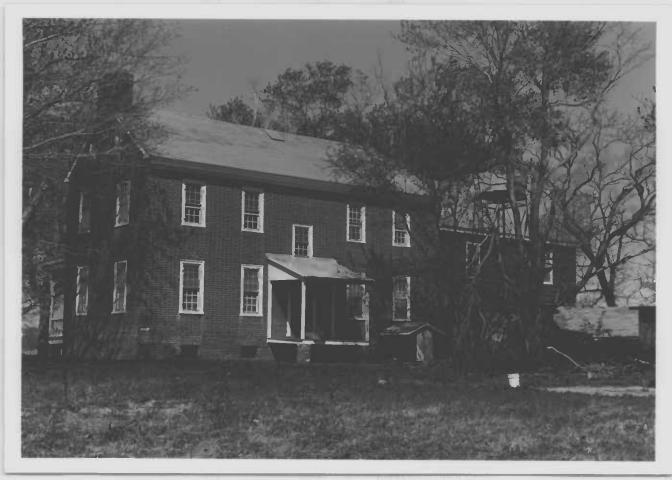
QA-66 C.P.Merrick Farm
Merrick Corner
Ingleside vicinity
Orlando Ridout V 1980
Rear facade

The rear façade is similar to the front façade, with a central door flanked by two 9/9 windows on each side of the first floor. On the second floor, a 6/6 window is down-set in the center bay, flanked by two 9/6 windows on each side. There are five cellar windows with horizontal iron bars. The brickwork is Flemish Bond above a three-course bond foundation. Filled put-log holes are clearly visible on this façade, as well as the west and north walls. The eaves are boxed in with a large complex crown mold and bed mold. The center door is relatively low in height due to the interior stair landing. The six-panel door is set off by paneled soffit and jambs and a crossetted architrave. Filled holes in the brick walls to left and right of the door are evidence of an original entrance porch, now replaced by a simple one-story lean-to that protects the center bay. A brick to the right of the door is inscribed "1805."
